DERELICT BUILDING GRANT PROGRAM

Derelict Building Address: 301 State Street, Guthrie Center, IA 50115

Derelict Building Grant Program
Supporting Materials – Photo Descriptions
City of Guthrie Center

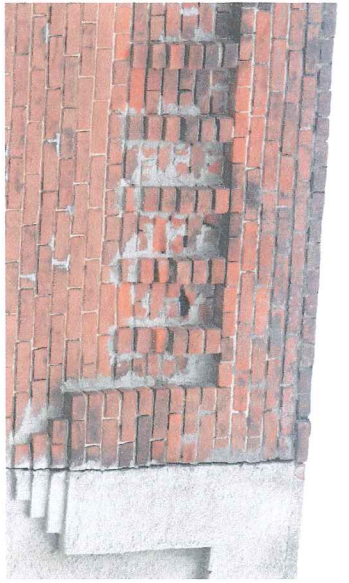
1

Once all asbestos has been removed a structural engineer must be consulted as this building is believed to share a common wall with a drugstore to the east. There is evidence that the two locations are separating (see Photos #1 and #24).

1. Front view. Upper East side of building where it may or may not have a common wall with the building to the East. Building has begun to split away.
2. Front view. Bricks on upper side appear to have no mortar to keep them in place. Appears there is evidence of past repairs to mortar.

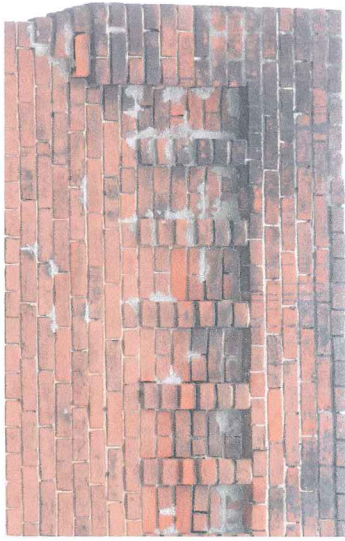
3

3. Front view. Bricks on upper side appear to have no mortar to keep them in place. Appears there is evidence of past repairs to mortar.
4. Front view. Upper windows. Window to the left (West) appears ready to fall to sidewalk below.

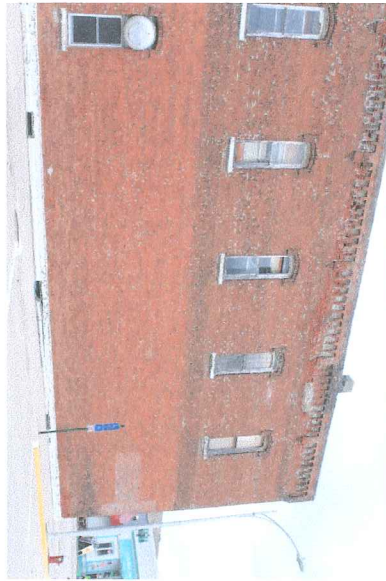
6

5. Rear view. East side of building where it meets building to the East.
6. West Wall view – front 2/3 of building. Appears there is evidence of past repairs to mortar.

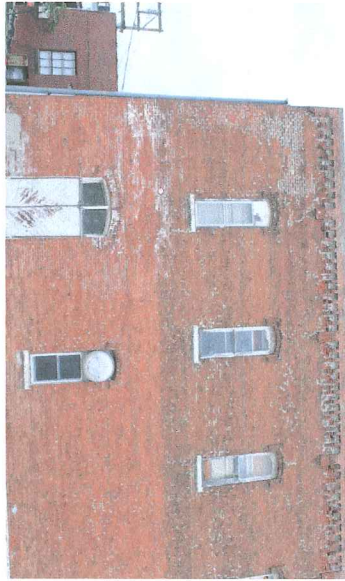
7

7. West Wall view – back 1/3 view. Appears there is evidence of past repairs to mortar.
8. West Wall view at sidewalk level showing basement windows and potential foundation problems.

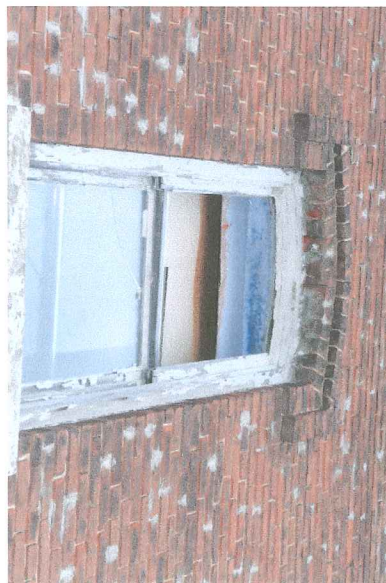
10

9. Front view.
10. West wall view. Appears that window covering are not securely in place to keep weather out of the building.
11. West wall view. Bricks appear to have no mortar to keep them in place. Appears there is evidence of past repairs to mortar.

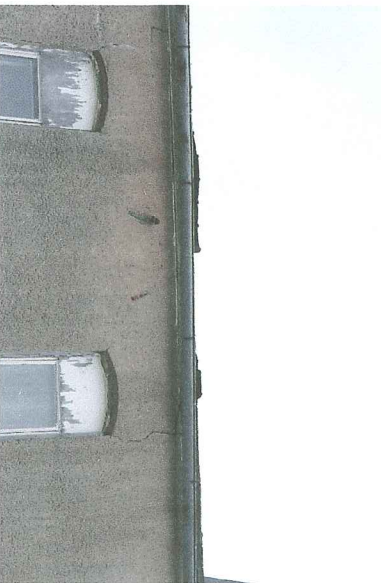
12

12. Rear view. Roof line showing roofing material pulling away from roof.
13. Front view.
14. Inside view second floor. You can see plastic covering the ceiling tiles has fallen away due to water dripping in.

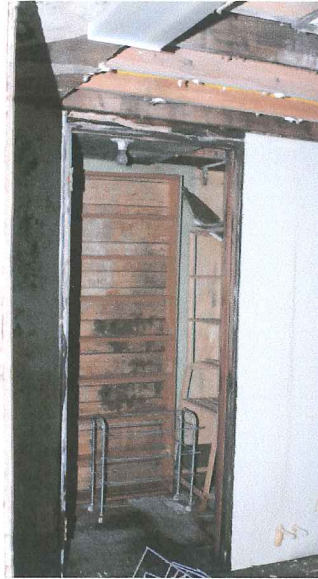
22

22. Inside main floor view. Black mold is visible on walls and ceiling. Sagging in ceiling is visible.
23. Stairwell view from second floor to main floor. Wall to the right appears to be bowing. This wall could be attached to the common wall.

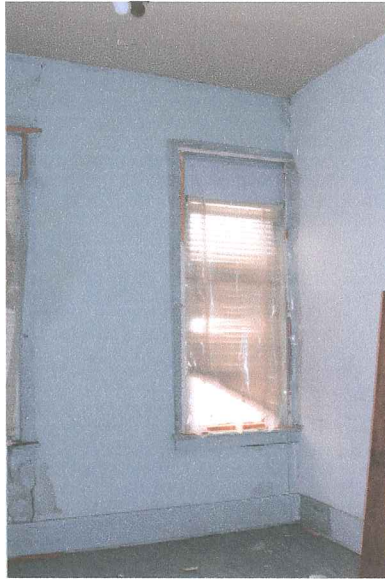
20

19. Inside view main floor. Elevator shaft.
20. Inside view second floor. You can see the water damage on the wall.
21. Rear view showing also the West side of the building.

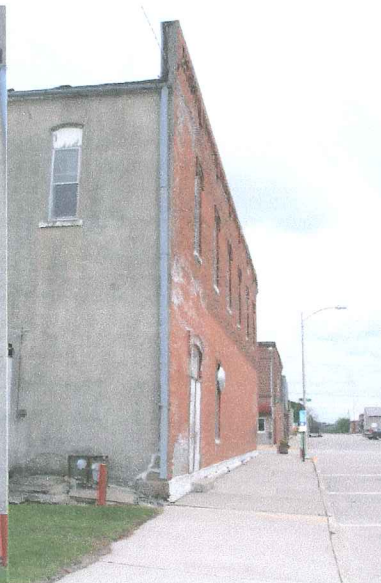
24

24. Front view. Upper East side of building where it may or may not have a common wall with the building to the East. Building has begun to split away.

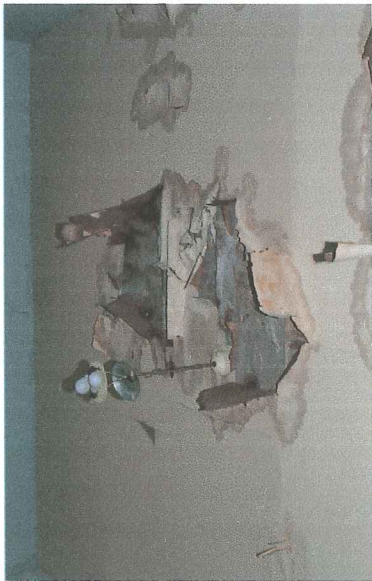
25

25. Inside view second floor ceiling. Water damage shots in various areas of ceiling.
26. Inside view second floor ceiling. Water damage shots in various areas of ceiling.

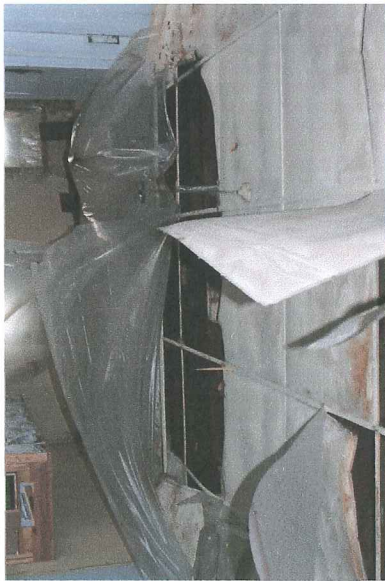
27

27. Inside view second floor ceiling. Water damage shots in various areas of ceiling.

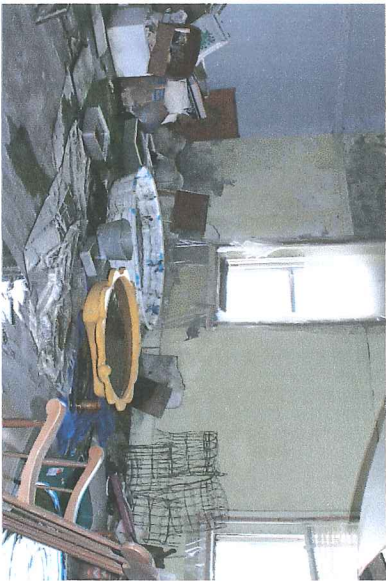
28

28. Inside view second floor. Swimming pools showing water collecting from roof leaks.
29. Inside view second floor ceiling. Water damage shots in various areas of ceiling.

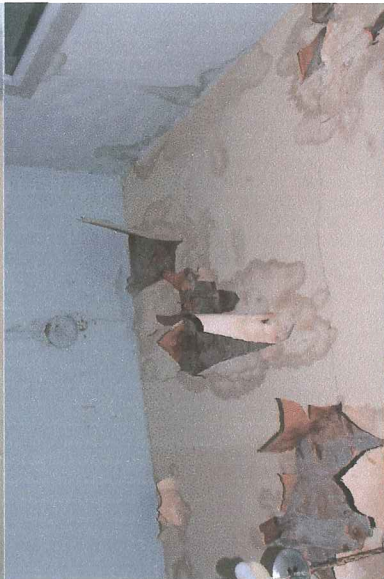
30

30. Inside view second floor ceiling. Water damage shots in various areas of ceiling.
31. Inside view second floor ceiling. Water damage shots in various areas of ceiling.

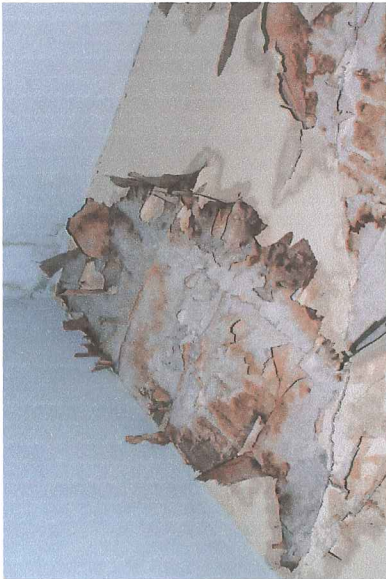
32

32. Inside view second floor ceiling. Water damage shots in various areas of ceiling.
33. Inside view second floor ceiling. Water damage shots in various areas of ceiling.

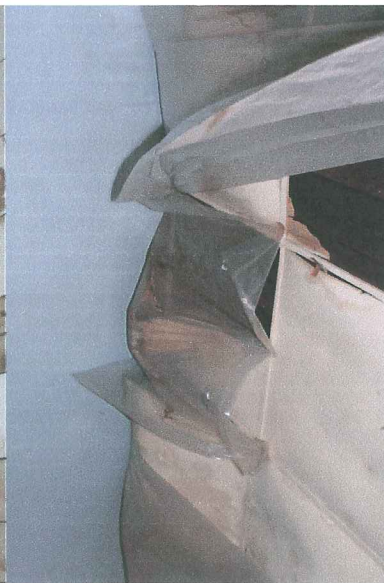
34

34. Inside view second floor ceiling. Water damage shots in various areas of ceiling.
35. Inside view second floor ceiling. Water damage shots in various areas of ceiling.

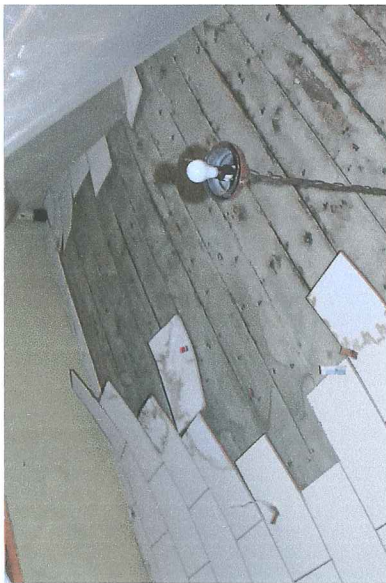
36

36. Inside view second floor ceiling. Water damage shots in various areas of ceiling.
37. Inside view in loft area between first and second floor. Appears to show extensive water damage and mold.

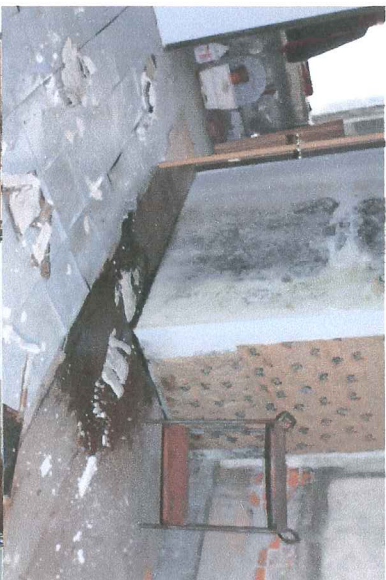
38

38. Inside view main floor. Shows black mold and water damage.
39. Inside view main floor. Shows black mold.
40. Inside view main floor. Shows water damage on the floor – water appears to be from either the roof or the window in the second floor that is not tightly secured.

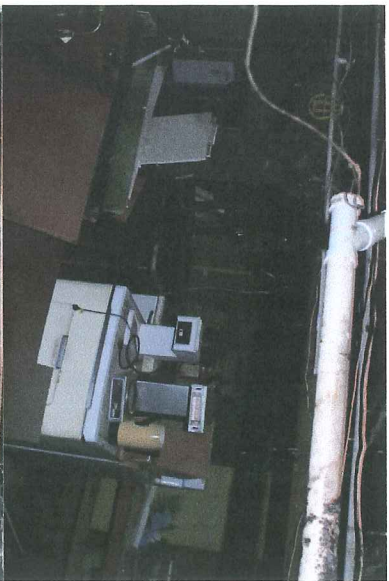
41

41. Inside view basement. Mold evident on pipe. Was unable to determine if water was on floor.
42. Inside view basement. Appears there may be water was on floor.

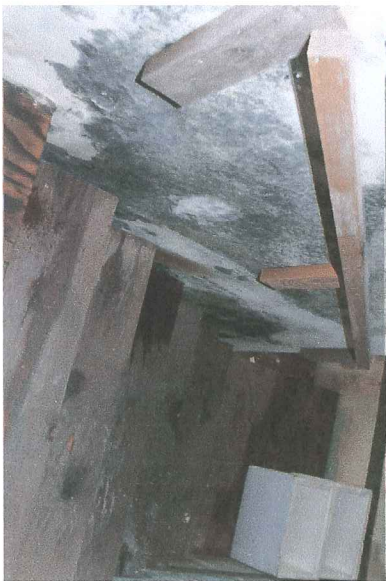
43

43. Inside view descending stairs from second floor. Black mold evident from water damage.
44. Inside view in loft area between first and second floor. Appears to show extensive water damage and mold.

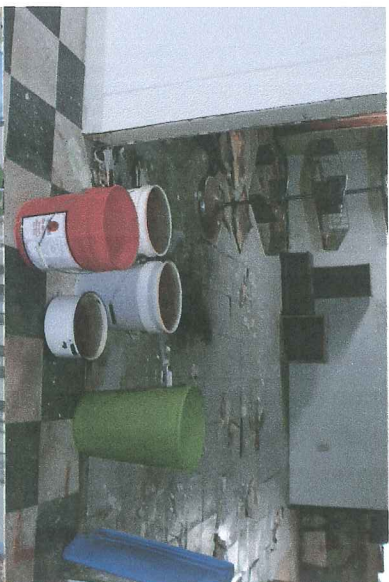
45

45. Inside view main floor. Shows buckets set up to catch water that are over flowing.
46. Outside view along West side of building. Shows crack in sidewalk covering downspout.

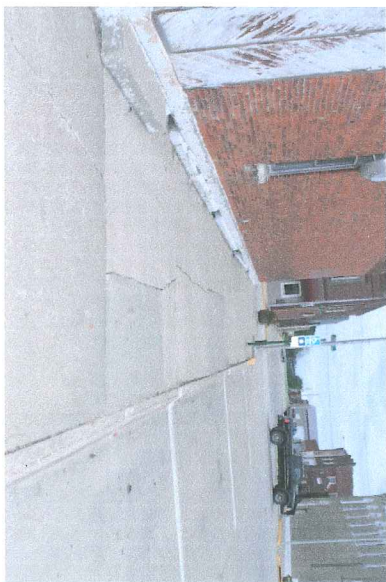
47

47. Outside view along West side of building. Shows crack in sidewalk covering downspout.
48. West Wall view at sidewalk level showing basement windows and potential foundation problems.
